# Syncope triggered by atrial flutter in a patient with a pacemaker: cross-stimulation—a case report

Olga Durán-Bobin<sup>1\*</sup>, Francisco Crespo-Mancebo<sup>1</sup>, Juliana Elices-Teja<sup>1</sup>, and Carlos González-Juanatey<sup>2</sup>

<sup>1</sup>Cardiac Arrhythmia Unit, Cardiology Department, Hospital Universitario Lucus Augusti, C/Ulises Romero s/n, 27003, Lugo, Spain; and <sup>2</sup>Cardiology Department, Hospital Universitario Lucus Augusti, Lugo, Spain

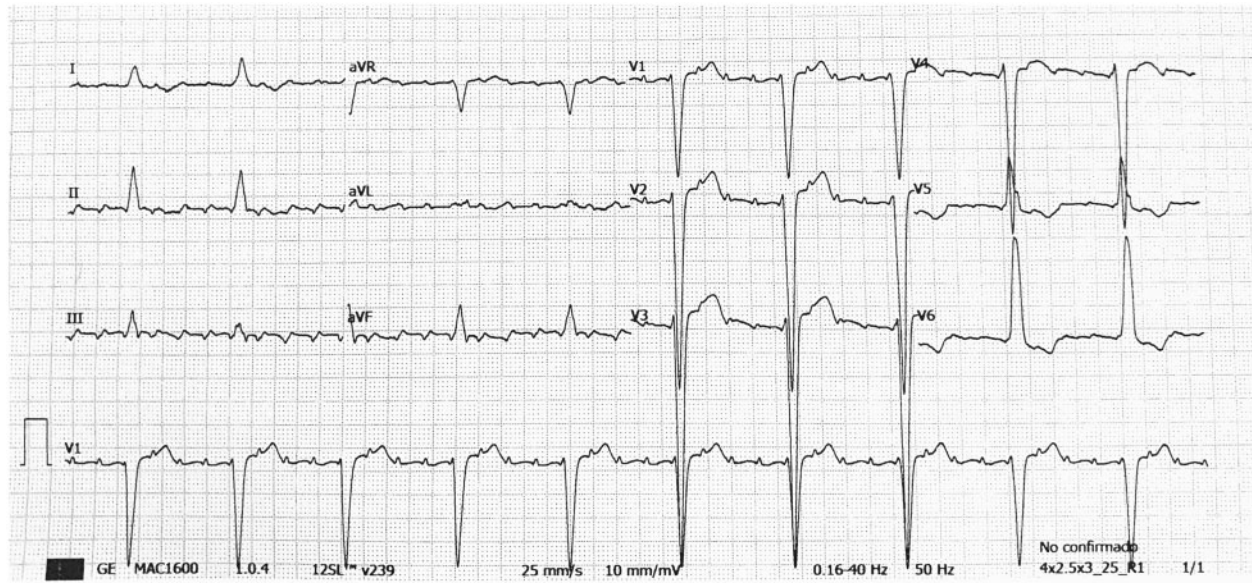
The clinical examination did not reveal any abnormality. The ECG (Figure 1) showed common atrial flutter, left bundle branch block morphology of the QRS complex, and a ventricular rate of 62 b.p.m. The chest X-ray showed both leads to be at their expected positions: one lead in the right atrial appendage and the other lead in the right ventricle outflow tract (Figure 2A,B).

**Figure 1** The electrocardiography showed common atrial flutter, left bundle branch block morphology of the QRS complex, and a ventricular rate of 62 b.p.m.

At initial presentation, the ECG showed atrial flutter (Figure 1). The first diagnostic suspicion was the dislodgement of the atrial lead into the ventricle. The chest X-ray ruled out that possibility. The ECG showed ventricular capture during pacing in AAI mode. This confirmed the cross-stimulation due to the switching of the atrial and ventricular leads at the pacemaker header.

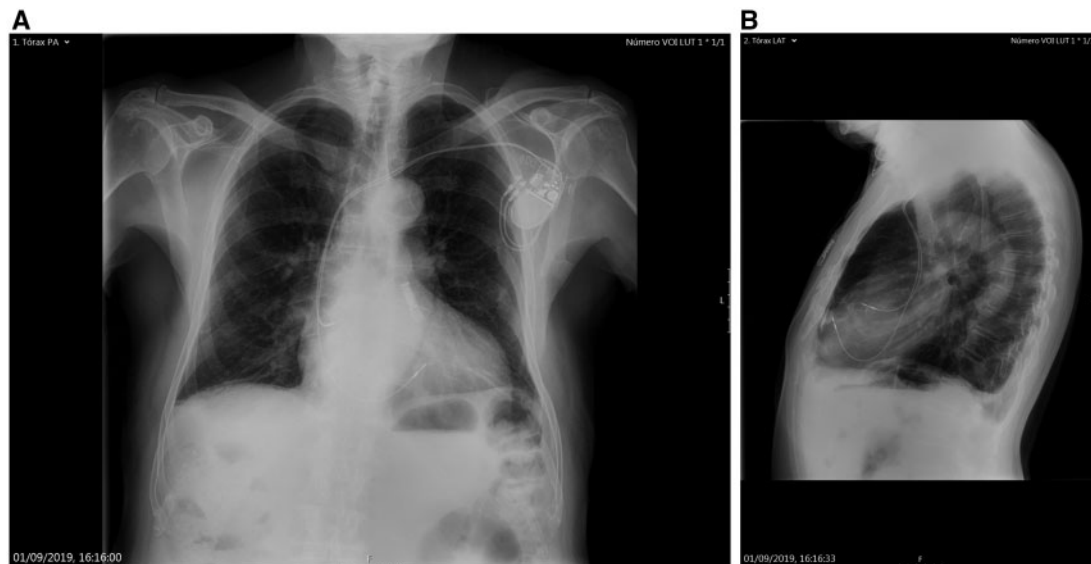
**Figure 2** (A,B) The chest X-ray showed both leads to be at their expected positions: one lead in the right atrial appendage and the other lead in the right ventricle outflow tract.

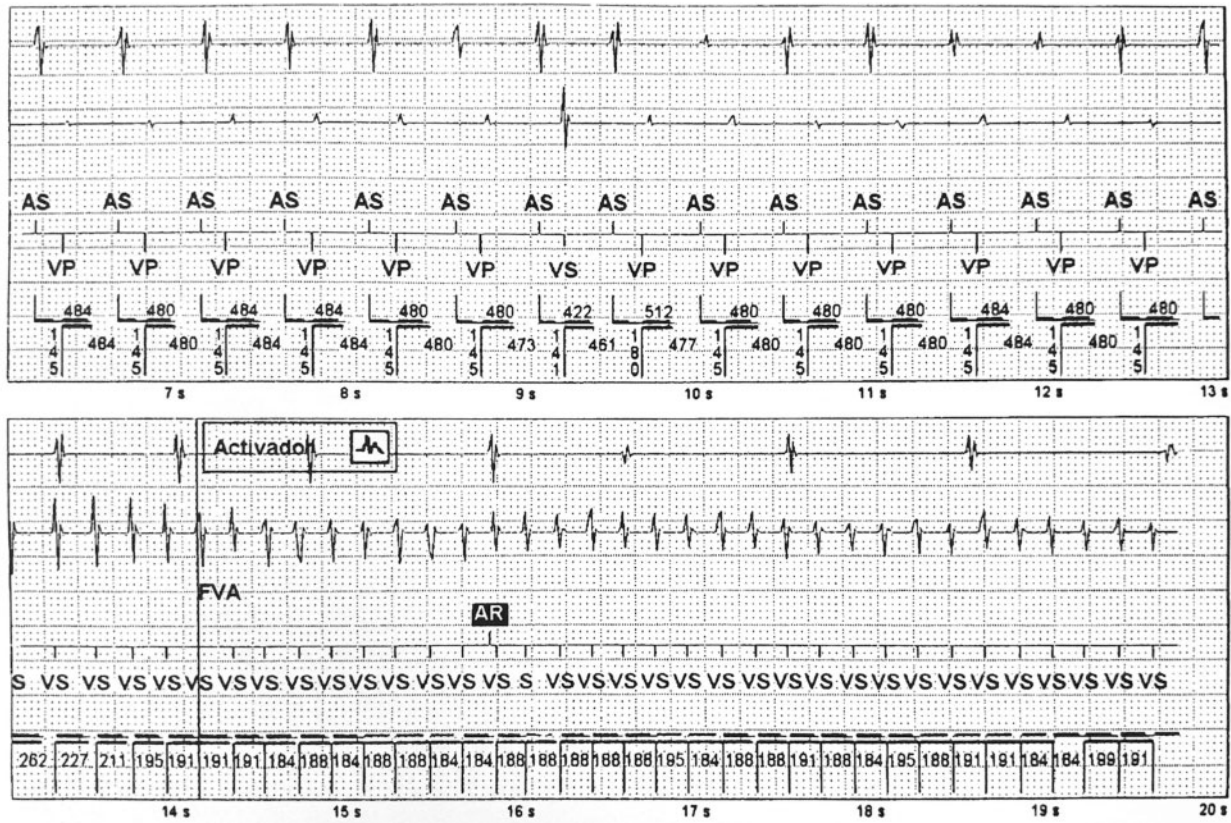
We checked the device. It was programmed to DDD mode, with a lower rate of 60 b.p.m., the paced AV delay was 200 ms, and the sensed AV delay was 150 ms. The stored EGM showed several episodes of fast ventricular rate (Figure 3). The first part of the tracing shows the rhythm of the patient interpreted as atrial sensing-ventricular pacing (AS-VP), with one ventricular sensed beat. Then, a fast rhythm at the ventricular channel develops with a cycle length around 190 ms. For atrial pacing, the ECG showed ventricular demand pacing (VVI) pacing (Figure 4). The ventricular capture during pacing in AAI mode confirmed cross-stimulation due to the switching of the atrial and ventricular leads at the pacemaker header. This was corrected after opening the generator surgically.

**Figure 3** The stored EGM showed several episodes of fast ventricular rate. The first part of the tracing shows the rhythm of the patient interpreted as AS-VP, with one ventricular sensed beat. Then, a fast rhythm at the ventricular channel develops.

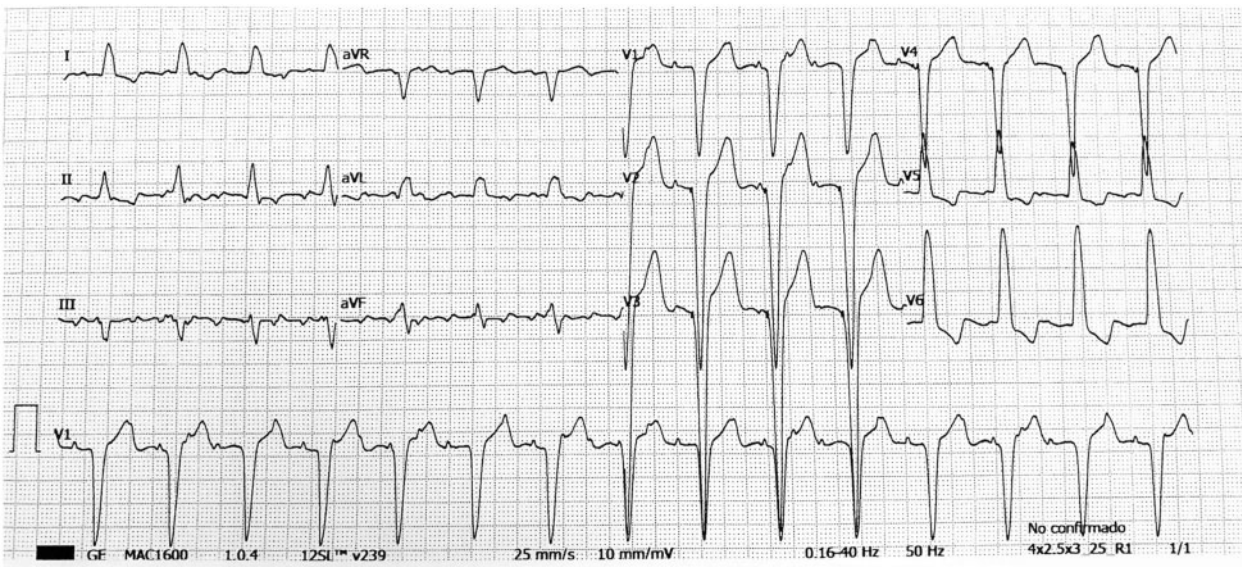
**Figure 4** For atrial pacing, the electrocardiography showed VVI pacing.

In order to avoid such an embarrassing complication, in patients with intermittent bradycardia, pacing at a slightly higher heart rate during implantation of the device should be recommended to see the chamber paced with the surface ECG connected to the device interrogator. The ECG and EGM should correlate during device implantation, but also during a device interrogation.<sup>9</sup> The correlation of the ECG and EGM during the device interrogation when the patient came to the hospital with syncope led to the correct diagnosis. If this had been done during the device interrogations, the diagnosis would likely have been made before the patient had symptoms.
